GGVDesigns PLLC

DP20-0046 + HPZ-19-72 Historical Review Continuation 419 S. 5th Ave Tucson, Arizona

Project Description and Applicants Request:

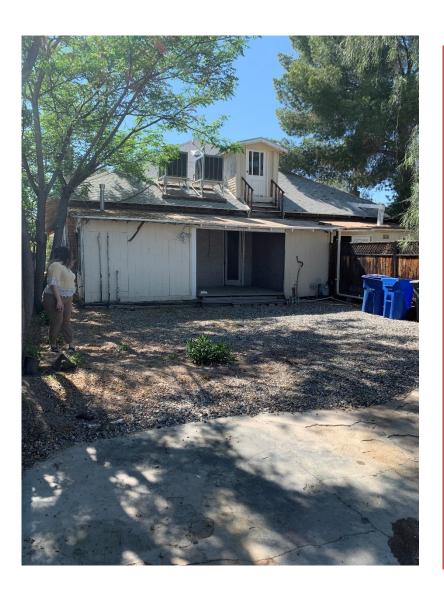
EAST ELEVATION

The east elevation picture shows the roof top ac units to be removed, t1-11 siding of porch enclosure, door and steps at attic, and miscellaneous ducting, and conduits proposed to be removed.

The wood fence at the north is proposed to be removed as well, refer to redevelopment drawings.

T-11 at gabled end at the attic is to be replace with material similar to the wood shakes on the north and south end of the elevation.

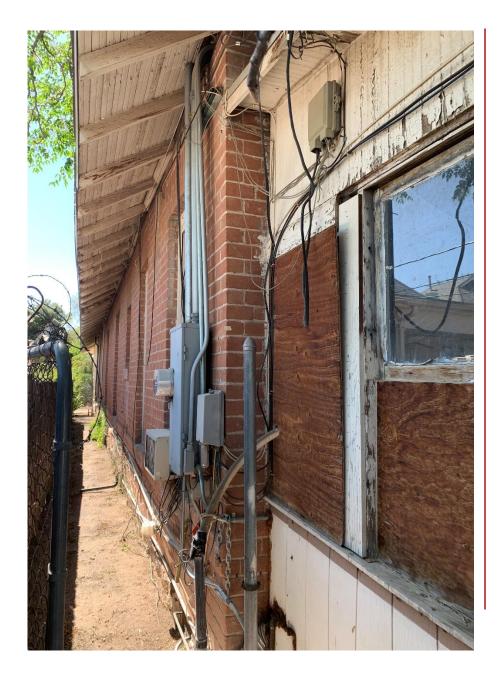
SOUTH ELEVATION

The south elevation picture shows the electrical switch gear, with electrical conduit and loose wire distributions that are proposed to be removed. All new electrical distributions are to be interior. The new meter is proposed as a multimeter configuration to match the scale and size shown on the elevations. The t1-11 siding and nonconforming window is proposed to be removed. The window mounted ac unit is also to me removed. The existing hung windows are to be refurbished by painting and improving operation.

The bottom of the deck is to be cleaned and painted

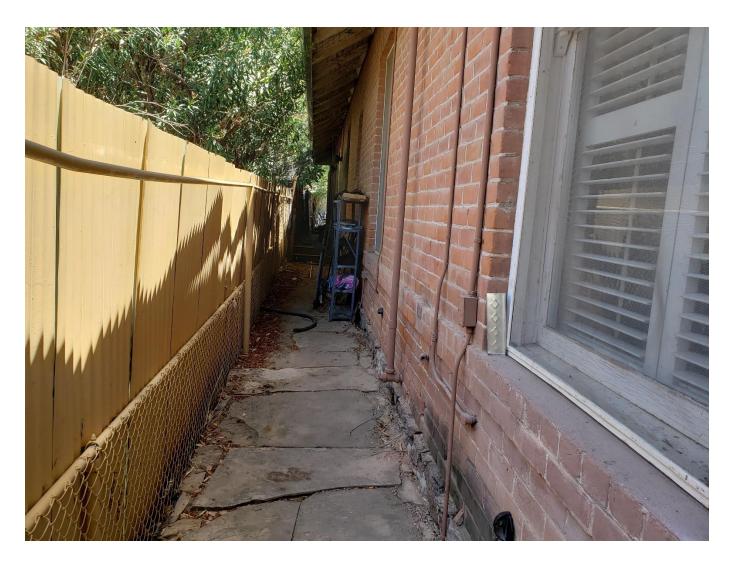
NORTH ELEVATION WEST END

The north elevation picture shows a miscellaneous conduit, wall sconces and vents that are proposed to be removed. North fence to be removed and replaced with a masonry wall. The wall is to continue screening, mitigate possible noise and enhance privacy to the neighboring property. We are also proposing to remove the stone walkway to comply with accessibility requirements, and pedestrian circulation / accessibility to public transportation.

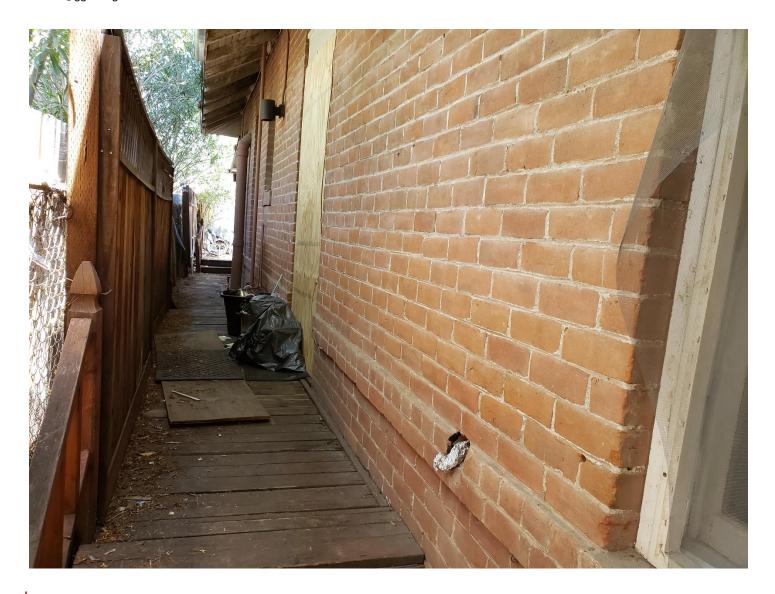
NORTH ELEVATION EAST END

The north elevation picture shows a wood deck that was set in place for a door opening that was created from an original window opening. We are proposing to remove the door, infill the masonry to sill height and add a custom window to match the existing windows. The owner is to fabricate these windows using reclaimed wood found on site that may have been from the original structure.

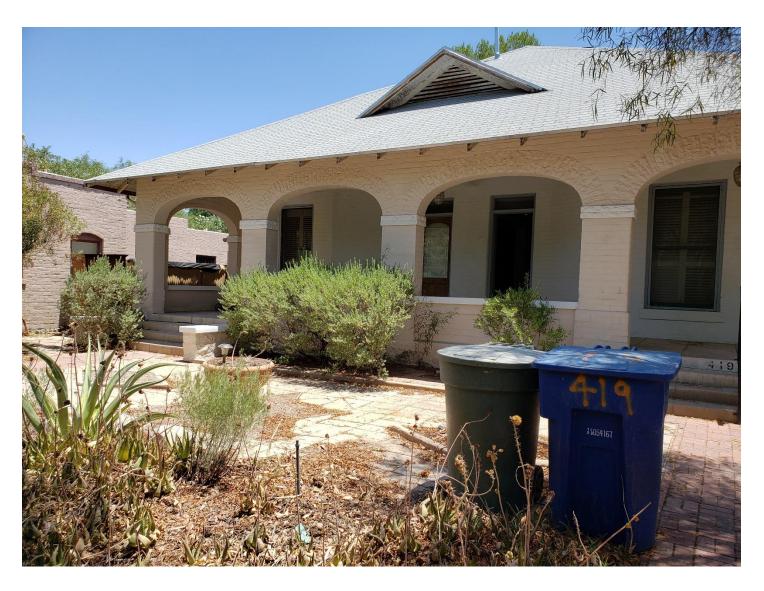
WEST ELEVATION

No change proposed to the west end besides paint and cleaning. Vegetation at street view is to be cleaned, removing oleanders and some vegetation that visually disrupts the façade.
